# Upgrading the imperix firmware IP

This page describes how to upgrade the imperix IP in an existing sandbox project, whether to restore compatibility with a newer SDK version or to access recent improvements. It also covers migration from a design targeting a Gen 3 controller (B-Box 3, B-Box Micro, B-Board PRO, TPI8032) to Gen 4 (B-Box 4).

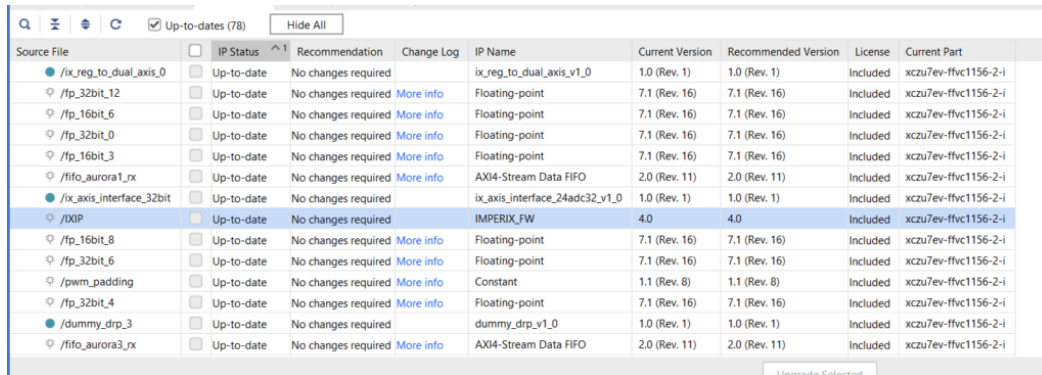
In Vivado, go to Reports → Report IP Status and look for the IMPERIX\_FW IP. The version is shown in the “Current Version” column. If no revision number is displayed, the revision is 0.

In this screenshot the imperix firmware IP version is **4.0 Rev. 0**

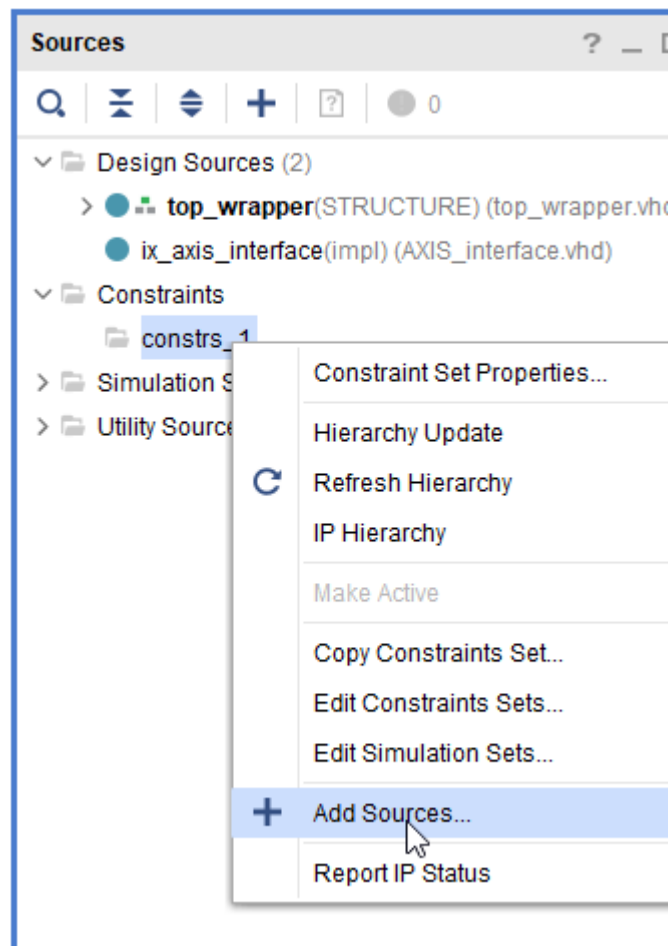
- Open the Vivado project
- Remove the old constraints file from Sources
- Add the new constraints file

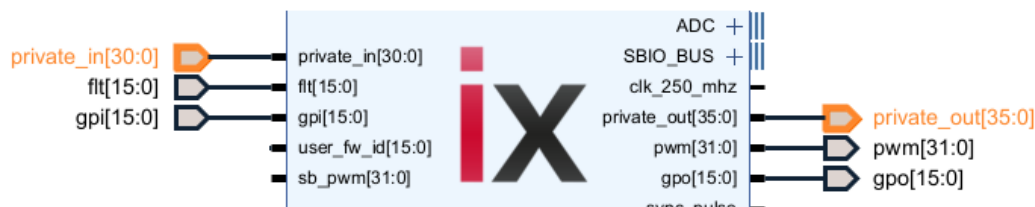
3. **Update the top-level ports** for private\_in and private\_out to match the new sizes.

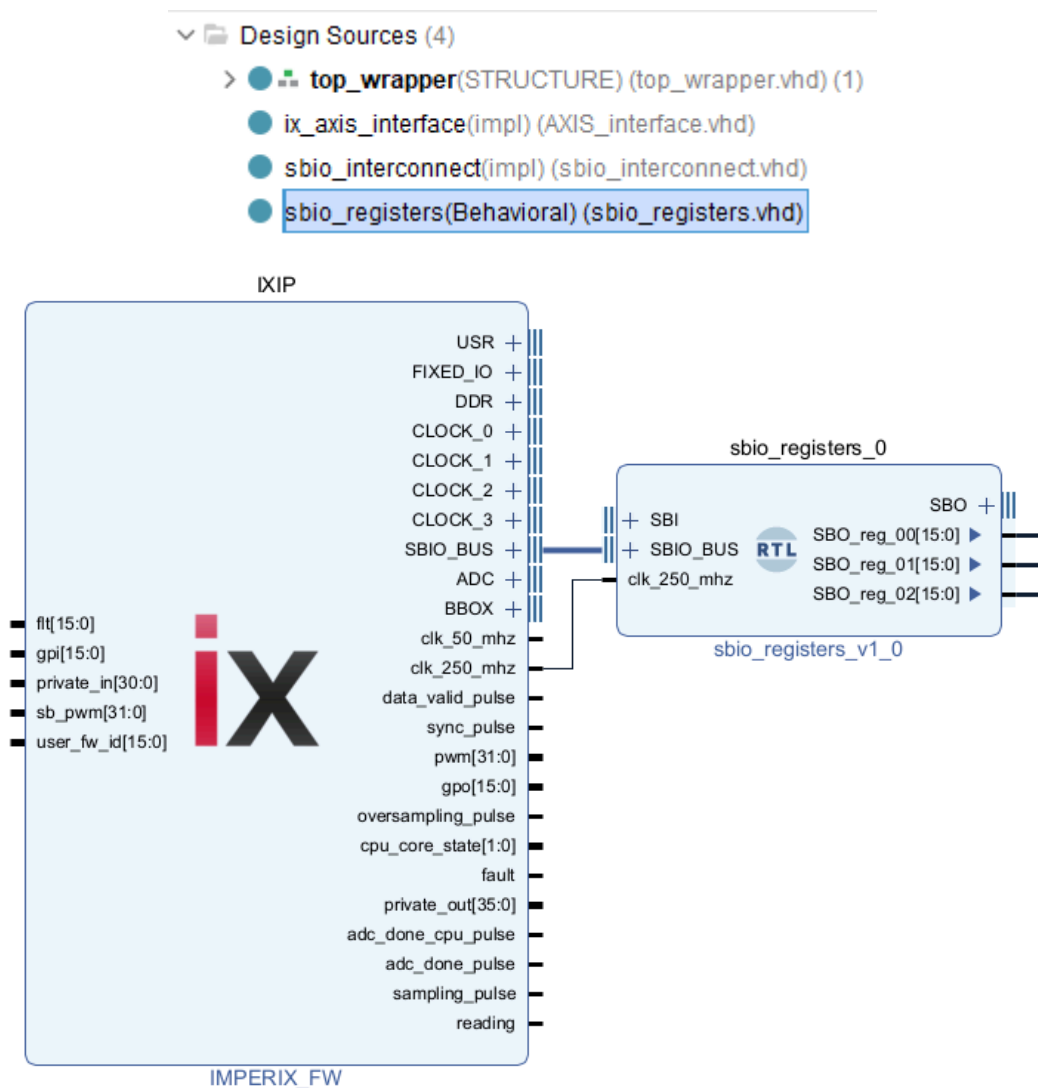
- Add the sbio\_registers module to the block diagram
- Connect existing logic to sbio\_registers (which now provides the SBI/SBO interfaces)
- Connect SBIO\_BUS from the imperix IP to sbio\_registers

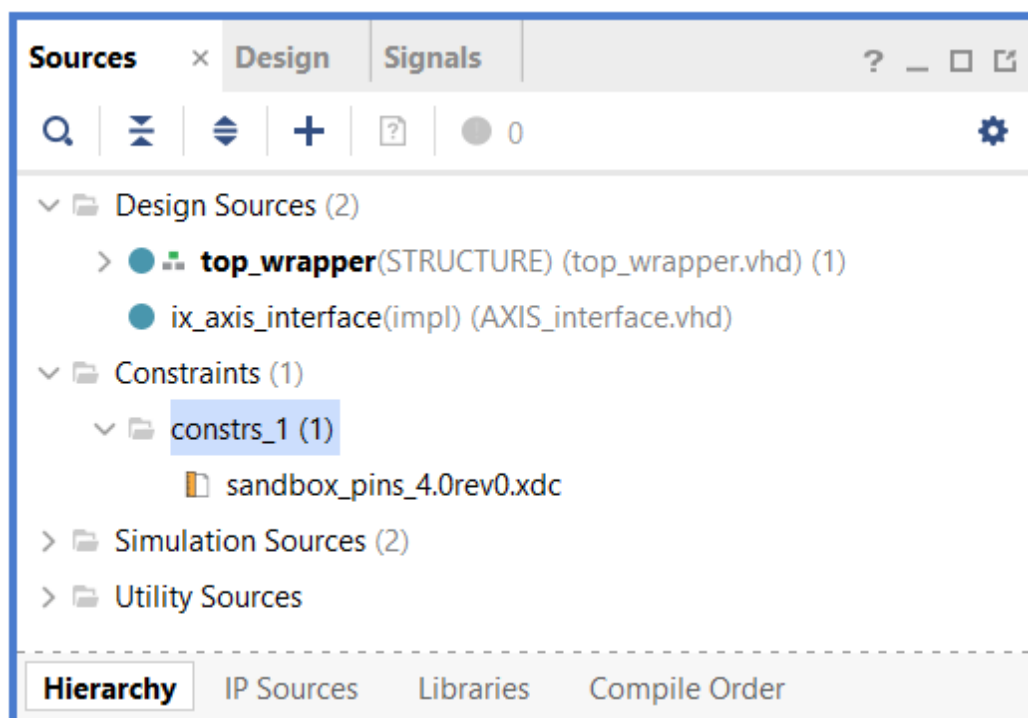
- If custom modifications were made to the constraints file, those changes must be manually transferred to the new file.
- Copy the constraints file from the Gen 4 template (constraints/) to the project's constraints/ folder, replacing the old file
- In Vivado, go to the **Sources** tab
- Remove the old constraints file from the project
- Add the new constraints file
